Servicing the Ferguson 3V29 VCR

Joe Cieszynski

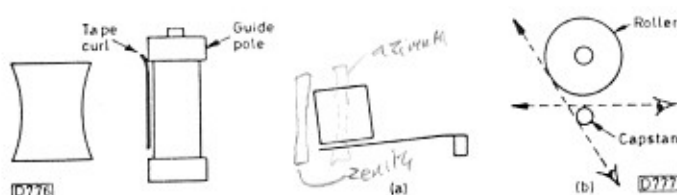
A pinch roller that has done more than a thousand hours of service generally needs replacement because it becomes concave, see Fig. 2. Thus the tape will slide up or down with respect to the audio/control head. The result is poor quality h.f. audio response or poor tracking due to loss of the CTL pulses. Both symptoms can be intermittent. Creasing of the tape edge may also occur.

The same symptoms can be caused by a distorted pinch-roller mounting bracket. It becomes distorted when excessive pressure is applied whilst removing the pinch roller fixing screw. It's worth checking for this during each routine service. Fig. 3 shows the method of checking the mounting.

Fig. 2 (left): A concave pinch roller results in uneven pressure on the tape, which will slip up or down on the exit guide pole. It's best to check the pinch roller by removing it.

Fig. 3 (right): It's essential that the pinch roller is vertical. A distorted pinch roller mounting bracket is shown at (a). The pinch roller can be checked, see (b), by pressing the roller towards the capstan with a finger, leaving just a narrow gap through which the roller can be sighted. Use the capstan as a reference. Check from two angles, as shown, for zenith and azimuth distortion.

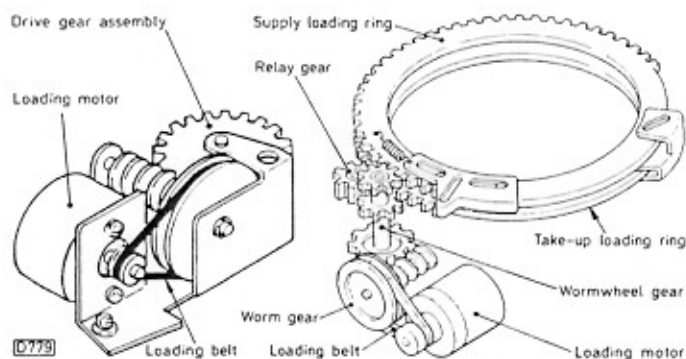
The loading belt in this machine is notorious. When it stretches it will either fail to close the after-load switch, as a result of which the machine will unload after about ten seconds, or it will fail to close the unload switch, with the result that the motors continue to rotate after unloading and the cassette housing won't open. Both symptoms may be intermittent.

Fig. 5: The loading block and loading rings. The simplest way to replace the belt is to remove the block, but note that the rings are then free to move and can thus become unmeshed.

(see Fig. 5) and release the circlip. But beware: when the motor assembly has been removed the two loading rings are free to move and, after reassembly, may be out of mesh. This problem can occur even when you take great care as you remove and replace the assembly. What usually happens is that the gears on the motor block rotate as you change the belt. Thus when the motor block is reinserted the gear teeth no longer locate with those in the rings. One's natural instinct is to gently juggle the motor block until the teeth are aligned, but this is when the rings move out of mesh. What you should do is to lower the motor block on to the rings and, if the teeth don't engage immediately, gently rotate the motor pulley until they do. The operation isn't difficult: I've managed it successfully in a customer's front room on many occasions.

If the rings do become unmeshed, remove the loading block, fully retract both the slant poles, look to see that the

teeth on both rings are aligned above each other, then reinsert the loading motor block. Now check the loading, ensuring that the guide rollers locate firmly in the V notches.
