Servicing the Ferguson 3V29 VCR

Joe Cieszynski

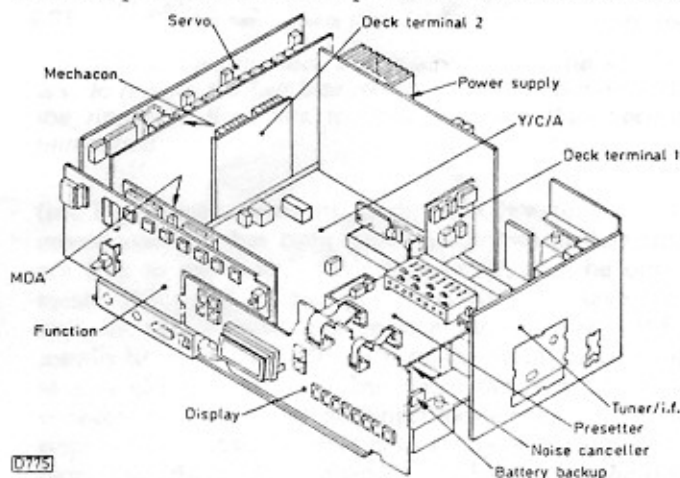
Fig. 1: Panel layout. The earliest versions didn't have the noise-canceller board or battery back-up. On later versions the MDA circuit was put on to the servo board, leaving an empty compartment behind the function board. On the stereo sound version this compartment was used to house the additional audio circuits. The deck terminal 2 board is needed only with the combined servo/MDA board: it was added to accommodate the interconnections between the MDA, the system control and the motors.

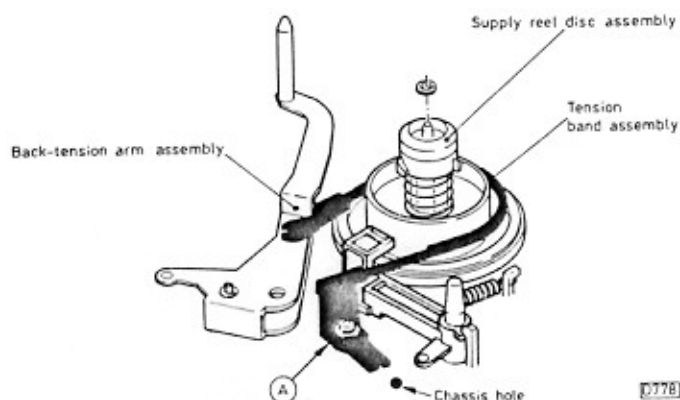
Fig. 4: The back-tension assembly.

The back-tension band is not a source of trouble with these machines. If it appears to be well worn however it should be replaced. According to the service manual the torque should be set at between 30-40g-cm, using a back-tension cassette. The only correct way to set back tension is to use some form of tension gauge. If you are working on only the occasional machine however, out of interest rather than as a repair service, the 3V29 is, unlike many other models, very tolerant and will often allow you to set the tension using the method outlined below (see Fig. 4) – but I must emphasise that you do so at your own risk. Tension is adjusted by moving the foot (A) from left to right. Without a tension gauge, fitting a new band in the same mechanical position as the old one will usually give you approximately the correct tension. Where the original band has been moved (you can tell if the locking glue has been broken), approximately correct tension should be obtained by aligning the slot in the foot with the adjacent hole in the chassis. This forms a good starting point when you do use a tension gauge.

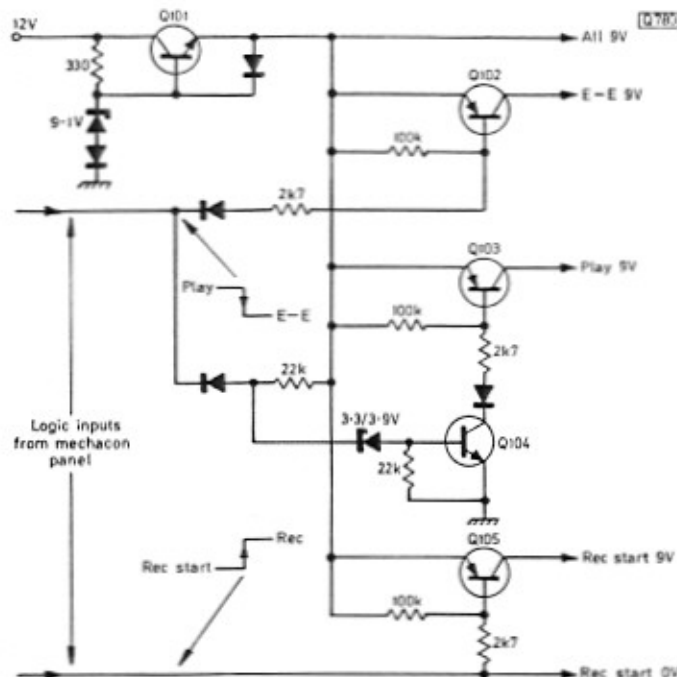
With any electronic equipment, ensuring that all the power supply lines are present and correct is an essential initial check. As with most VCRs the 3V29 has a number of supply lines that are switched to change the mode, i.e. the Play 9V, Rec 9V, E-E 9V etc. lines. Supply switching is carried out by a set of mode-control transistors on the YCA panel. An open-circuit transistor results in loss of the relevant supply. Problems also occur when one of the transistors is leaky, with the result that the supply is permanently present. This can be interesting. With a leaky E-E switch transistor for example the machine will record correctly but operation of the luminance, chroma and servo circuits in the play mode is totally incorrect as the circuits receive both the Play and E-E supplies. Fig. 6 provides an outline of the mode-control circuit.

Fig. 6: The mode-control circuit. It's on the YCA board.
